### Technical Bulletin

<b>Doc. No.:</b>	TS TB 011
<b>Effective Date:</b>	11/23
<b>Revision #:</b>	00
<b>Doc. Title:</b>	Low Water Error, Horizon Elite Ice Machine

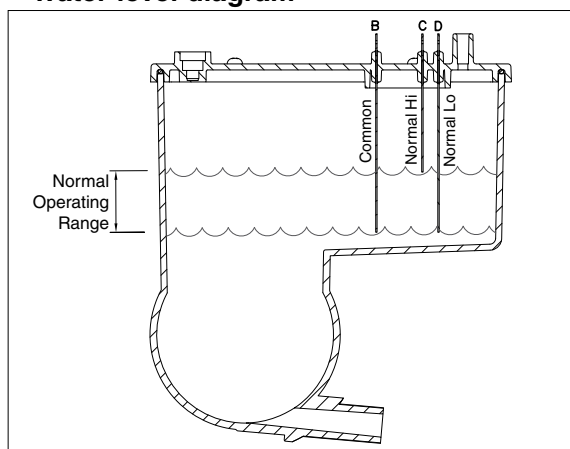
### Water level diagram

3. Circuit continuity – Continuity of the water detection control circuit and input to the control board should be verified. Ensure proper orientation of the machine's water level sensing probe wires. (Orange wire must be on the center terminal). Scale buildup on the probes can render them inoperable, and scale buildup on the underside of the reservoir lid can cause scale bridges that can disrupt the circuit's logic. The scale should be removed using an ice machine cleaner and a Scotch brite pad. Clean the underside of the reservoir lid between the probes and rinse away any debris prior to reinstalling the reservoir lid.
