A Time Delay Error where the ice maker's shuttle is triggered by a blockage of ice could be caused by a misalignment of Lane 1 and 2 in the Ice Manager Diverter Valve (IMDV). This happens when the linkage that switches Lane 1 and 2 is set to an incorrect length. The correct length between the linkages bolt heads is 4 1/4".

TI TS TBE 013  
rev00  
11/24

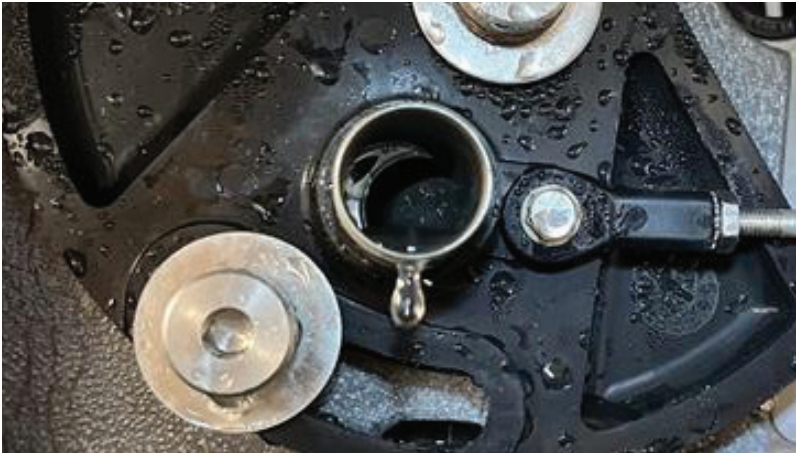
A slight misalignment between the two lanes can cause ice to jam inside the IMDV.
